# Manhole Inspection Summary

Manhole # S150\_\_014MH

Insp Date: **7/30/09 10:38 AM**

**Location** Address: **2801 FREDERICK AV**

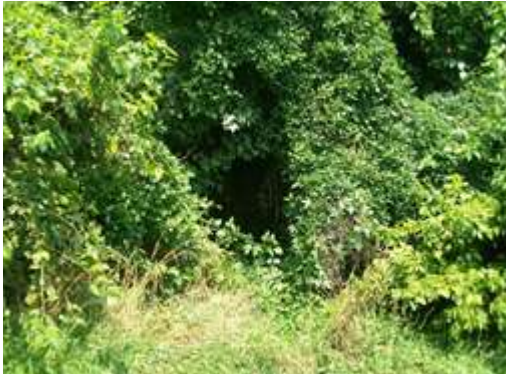
Miscellaneous

ACCESS POINT IN WOODS

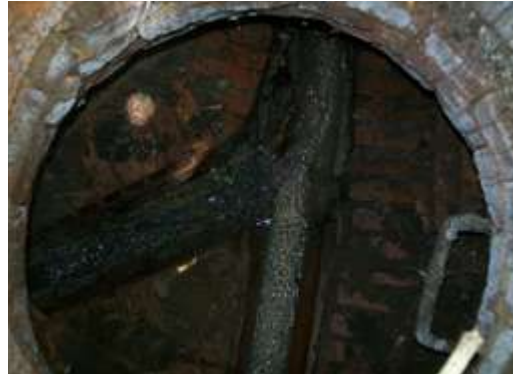
Defect 2

☒ **Corroded**

corroded step

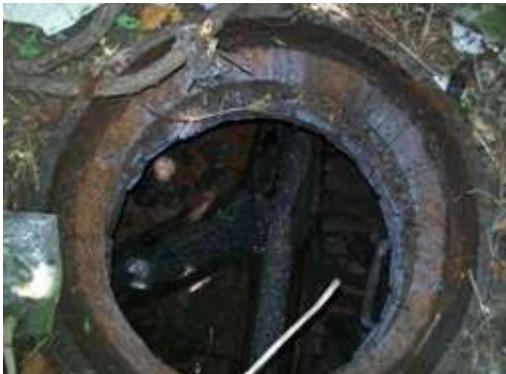
Defect 1

Offset: **2** (in.)

FRAME OFFSET

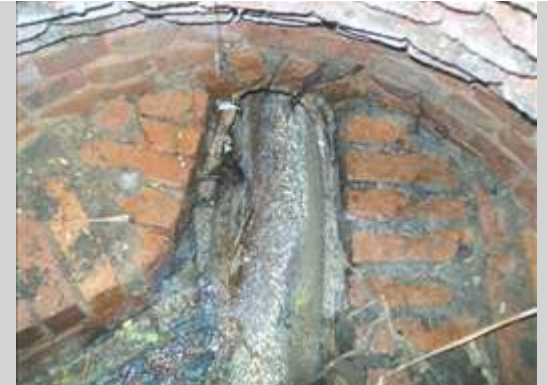
12 O'Clock Outflow

Pipe Height: **8.4** (in.) Rod and Bar (Angled)  
Pipe Material: **Clay** ☐ Pipe Lined  
Invert Depth: **4.50** (ft.) Flow Characteristics: **Slow**  
Deposits: ☒ None ☐ Mud ☐ Sludge ☐ Debris ☐ Grease  
Silt Depth: **0** (in.) Deposits Extent:  
Infiltration: **None** Pipe Seal Cond: **Roots**
